# Fracture failure analysis of safety valve spring in nuclear power plant

<sup>1</sup>Suzhou Nuclear Power Research Institute Co., Ltd, Suzhou 215004, China

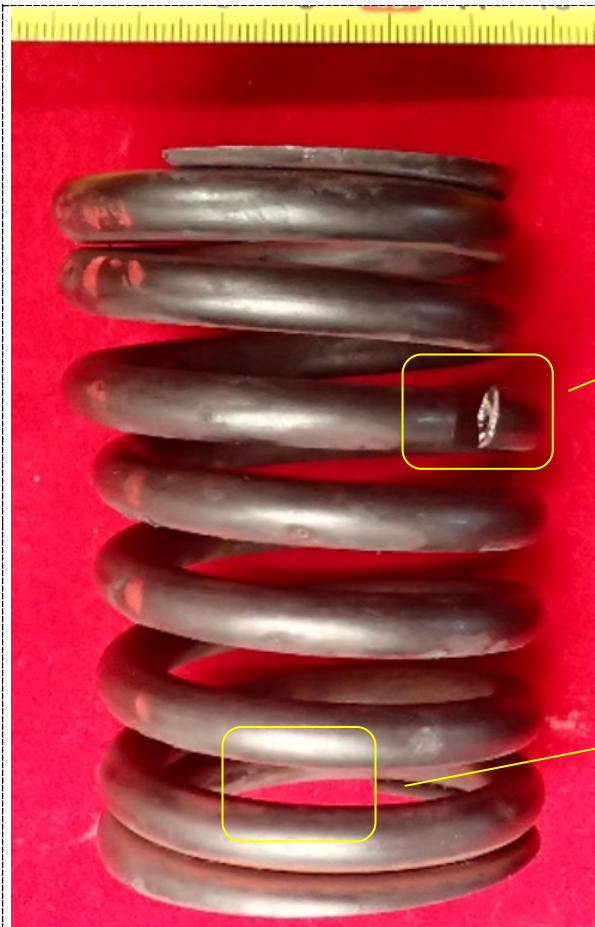
Figures 1-3 shows the macrostructure of the fractured spring. The spring shows varying degrees of corrosion marks on its surface, with localized pitting pits visible. The fracture is located in the fourth circle on the upper side of the installation, and the fractured surface is roughly divided into three areas. The upper and lower sides shown in the photo show corrosion marks, and a metallic luster can be seen in the middle area. The overall fracture is relatively flat, without obvious plastic deformation characteristics. In the middle area of the fracture, radiating edges and crystalline particles can be seen. The radiating edges converge at the lower side of the photo, indicating that the fracture starts from the

**Figure 1.** Macroscopic appearance of the fractured spring.

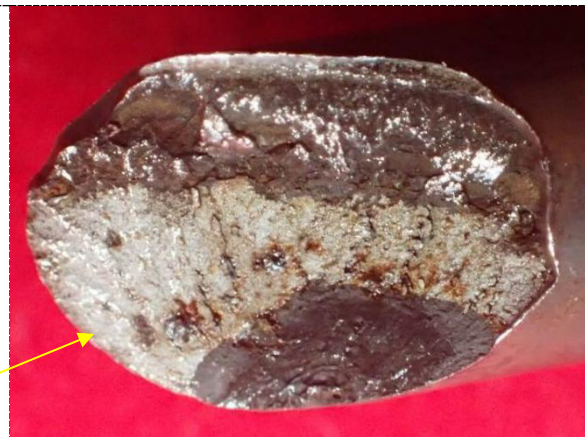
lower side of the photo and extends to the upper end. There are visible pitting marks in the initiation zone.

**Figure 2.** The fracture failure surface of the spring.

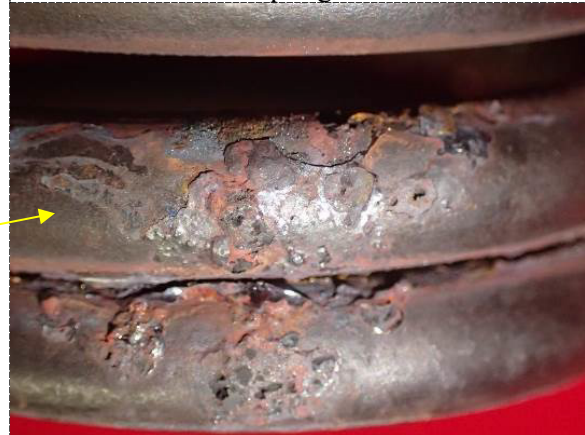
**Figure 3.** The localized surface of the fractured spring.

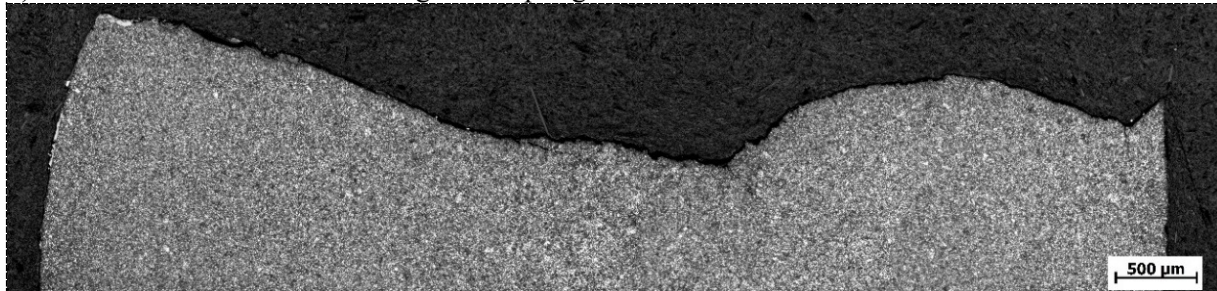
Figures 4-10 are the metallographic photo of the sample taken at the longitudinal section of the fracture and near the fracture. Figure 8 is the metallographic photo of the sample taken at the cross-section of the spring. The results show that: 1) the microstructure of the spring is tempered troostite; 2) corrosion and pitting marks can be seen in the cross-section and vicinity of the fracture, with extended cracks visible in the pitting pits, and secondary intergranular cracks and dendritic cracks visible in

local areas of the fracture; 3) no obvious decarburization marks are found on the surface of the spring; 4) The non-metallic inclusion rating of the spring is DT1.0DH0.5.

**Figure 4.** The longitudinal section of the fracture.

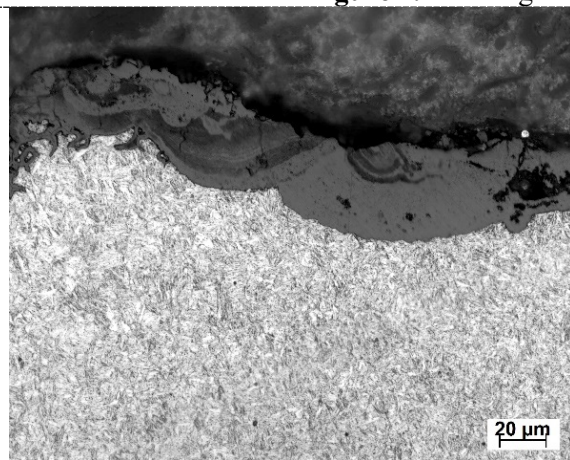
**Figure 5.** The localized longitudinal section of the fracture at area 1.

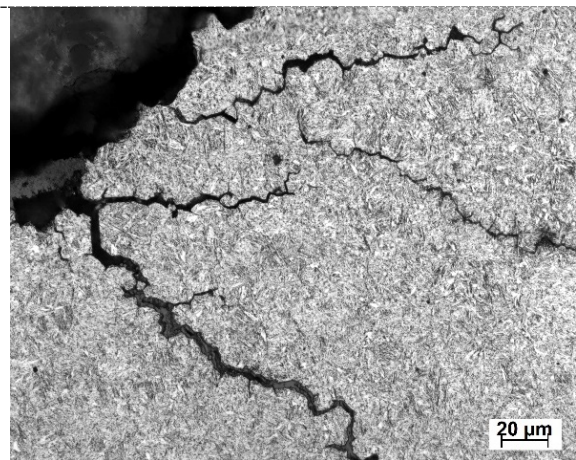
**Figure 6.** The localized longitudinal section of the fracture at area 2.

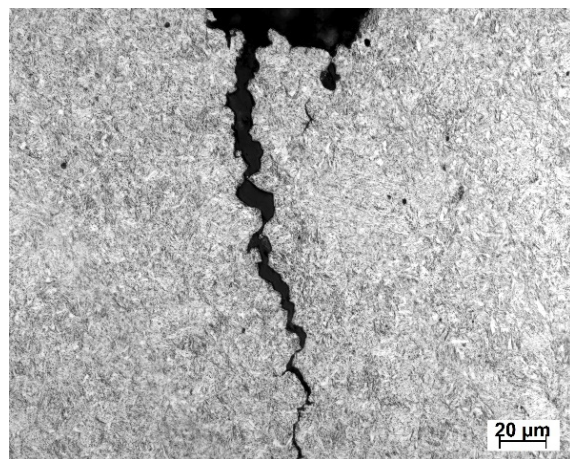
**Figure 7.** The localized longitudinal section of the fracture at area 3.

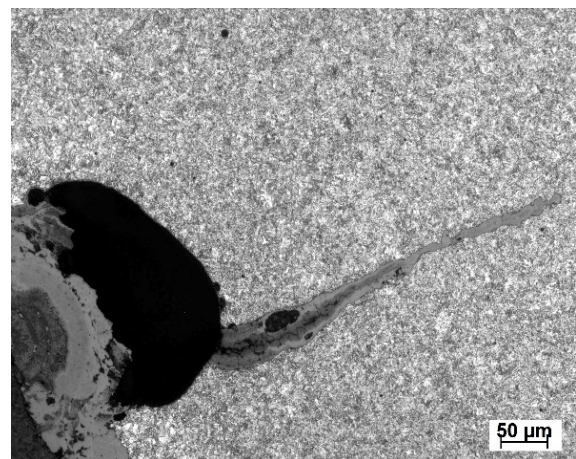
**Figure 8.** The longitudinal section of the spring near the fracture.

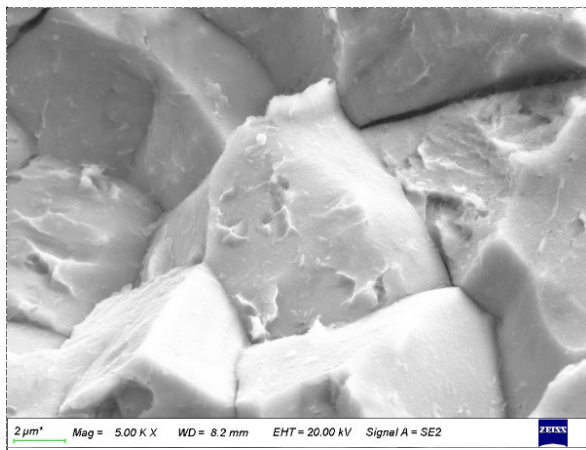
Figures 11-16 are the photos of the microscopic morphology of the fracture of the spring under the scanning electron microscope. The fracture starts from the lower side, as shown in the photo, and extends to the upper end. Pitting pits and corrosion marks can be seen in the initiation zone, while the uncorroded area presents an intergranular morphology. The extended and final fracture zones are mainly characterized by a rock-sugar-like intergranular morphology, with chicken claw patterns visible locally. At the same time, energy spectrum analysis was conducted on the pitting pits near the fracture section, indicating that the pits contain a certain amount of corrosive elements such as S and Cl.

**Figure 13.** Microtopography of area 2.

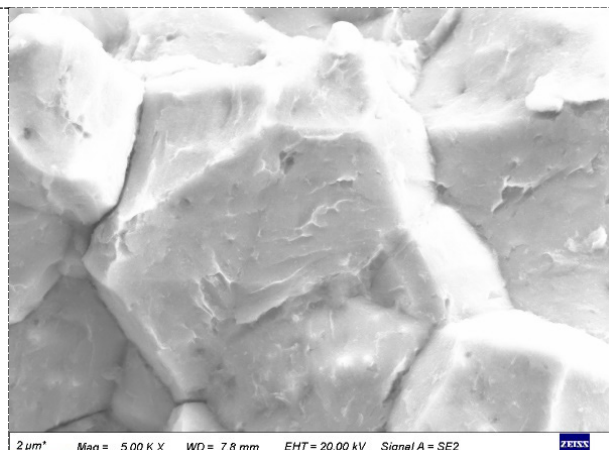
**Figure 14.** Microtopography of area 3.

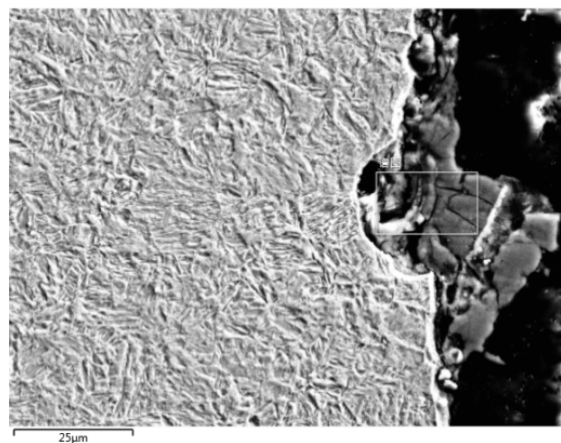
**Figure 15.** The EDS area of the fractured spring.

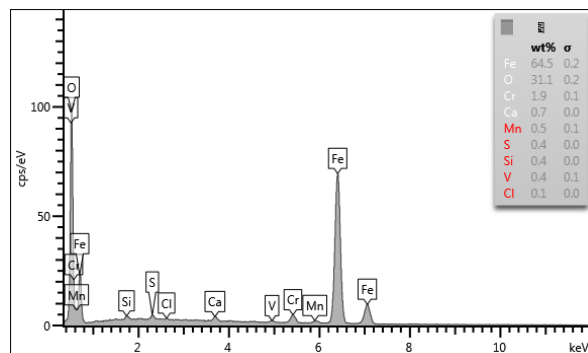
**Figure 16.** The EDS result of the chosen area.
