# Fracture failure analysis of safety valve spring in nuclear power plant

<sup>1</sup>Suzhou Nuclear Power Research Institute Co., Ltd, Suzhou 215004, China

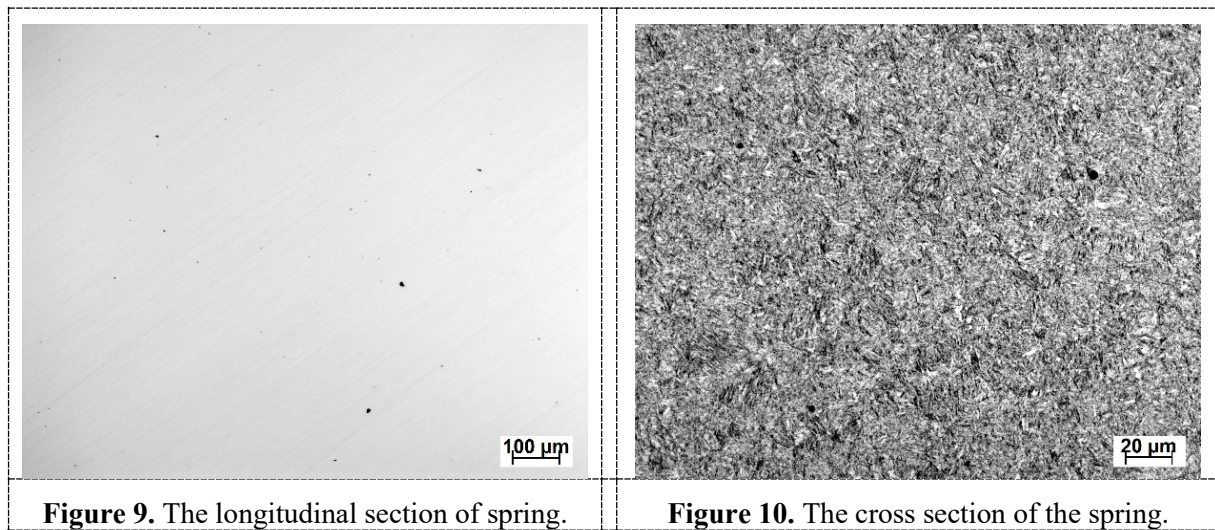
Figures 4-10 are the metallographic photo of the sample taken at the longitudinal section of the fracture and near the fracture. Figure 8 is the metallographic photo of the sample taken at the cross-section of the spring. The results show that: 1) the microstructure of the spring is tempered troostite; 2) corrosion and pitting marks can be seen in the cross-section and vicinity of the fracture, with extended cracks visible in the pitting pits, and secondary intergranular cracks and dendritic cracks visible in

local areas of the fracture; 3) no obvious decarburization marks are found on the surface of the spring; 4) The non-metallic inclusion rating of the spring is DT1.0DH0.5.

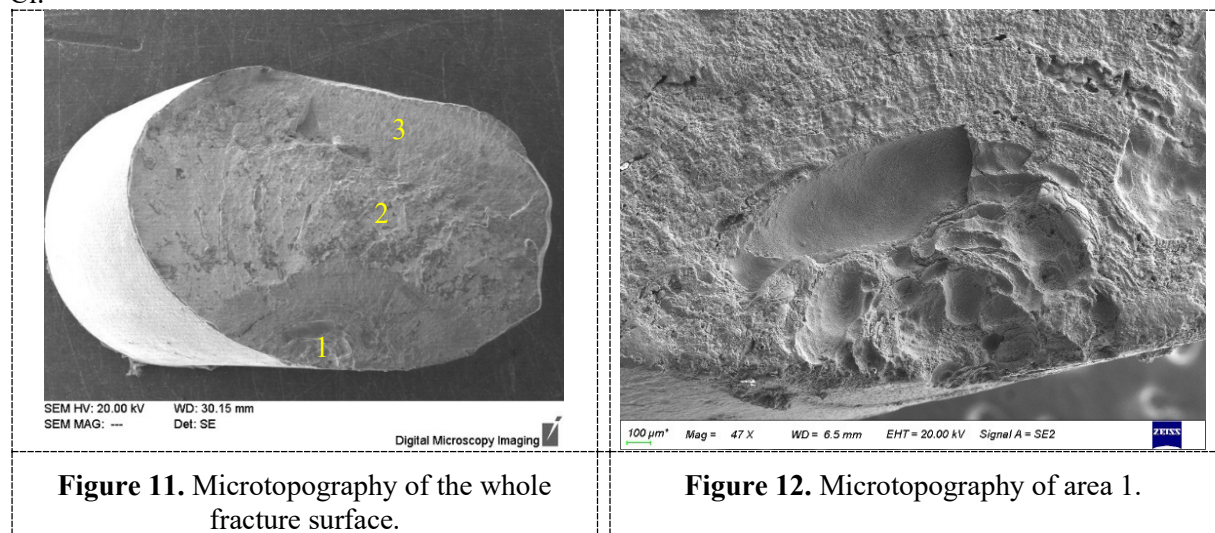
Figures 11-16 are the photos of the microscopic morphology of the fracture of the spring under the scanning electron microscope. The fracture starts from the lower side, as shown in the photo, and extends to the upper end. Pitting pits and corrosion marks can be seen in the initiation zone, while the uncorroded area presents an intergranular morphology. The extended and final fracture zones are mainly characterized by a rock-sugar-like intergranular morphology, with chicken claw patterns visible locally. At the same time, energy spectrum analysis was conducted on the pitting pits near the fracture section, indicating that the pits contain a certain amount of corrosive elements such as S and Cl.
